Stream/Wetland Restoration Plan

**2015-SM-Walnut Hill – Sousa B Property
Three Rivers Land Trust
Alfred, Maine**

September 2016

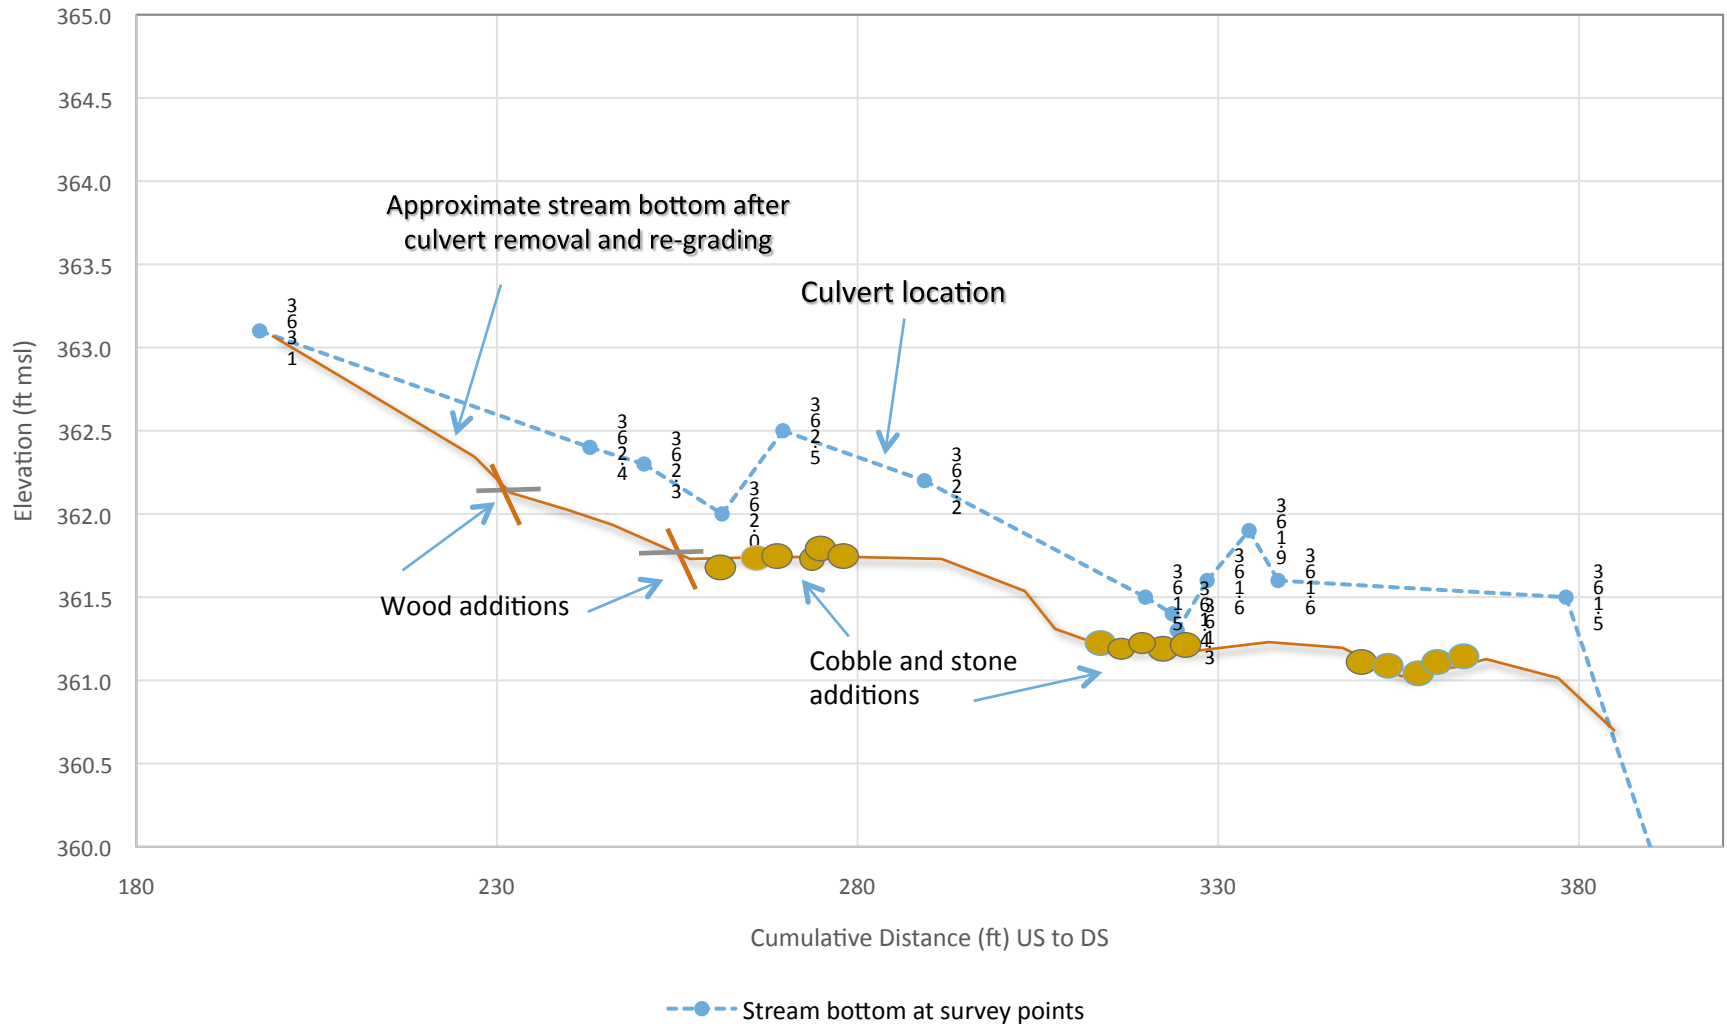
Figure 5 - Longitudinal Profile at culvert crossing showing pre - and post-restoration grades
Walnut Hill - Sousa B Property, Alfred, ME

Appendix D-1 and Figure 5 illustrate the restoration proposed for this area. At the stream, the culvert will be removed and the channel restored to match the overall slope between the upstream and downstream portions above and below the pools created by the culvert (Figure 5) to less than a 2% (0.02) slope. Much of the berm should be removed at the stream crossing, and an area approximately 40 feet upstream and about 30 feet downstream should be modestly modified to reconnect the areas of stream flow and reconnect the upstream and downstream portions of the wetland. This may also help to increase groundwater discharge to the stream.

The restored cross section at the culvert will blend the characteristics of the upstream and downstream characteristics and reduce impacts from high intensity storms. This process may also expose the finer grained sediment below and restore a streamflow pattern similar to the more natural upper and lower reaches. In addition, adding steps with instream woody materials and stone just upstream and downstream of the former culvert crossing will create habitat and lessen upstream head cutting. The stream channel will then naturally mature after several years when continuous flow is restored between the two sides of the stream.

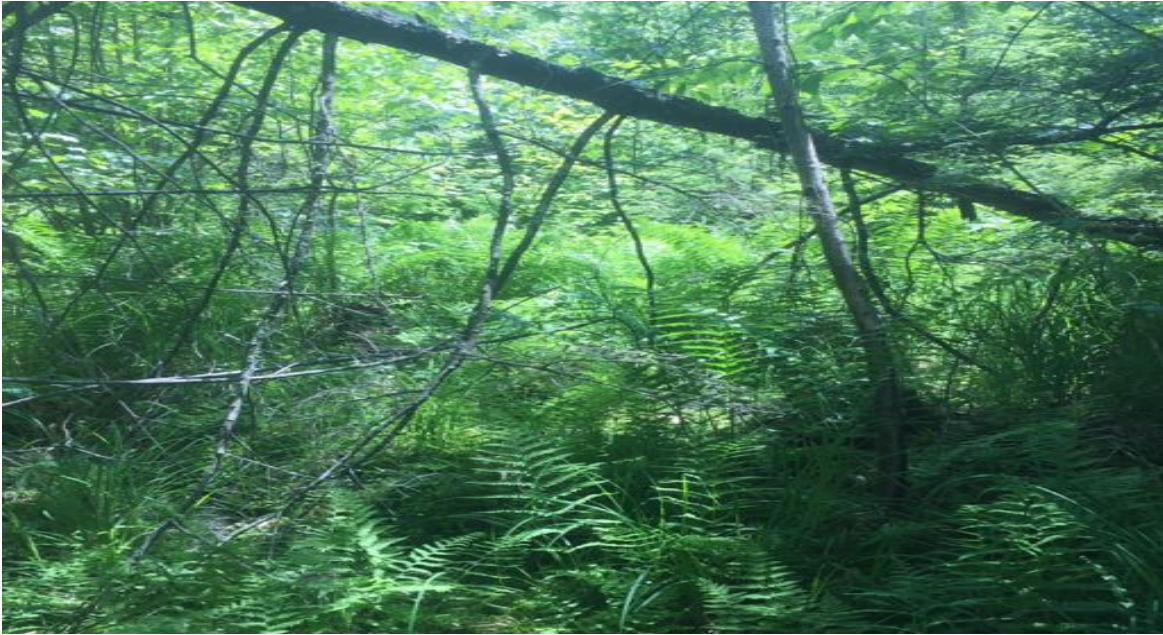
Facing west in Wetland 1

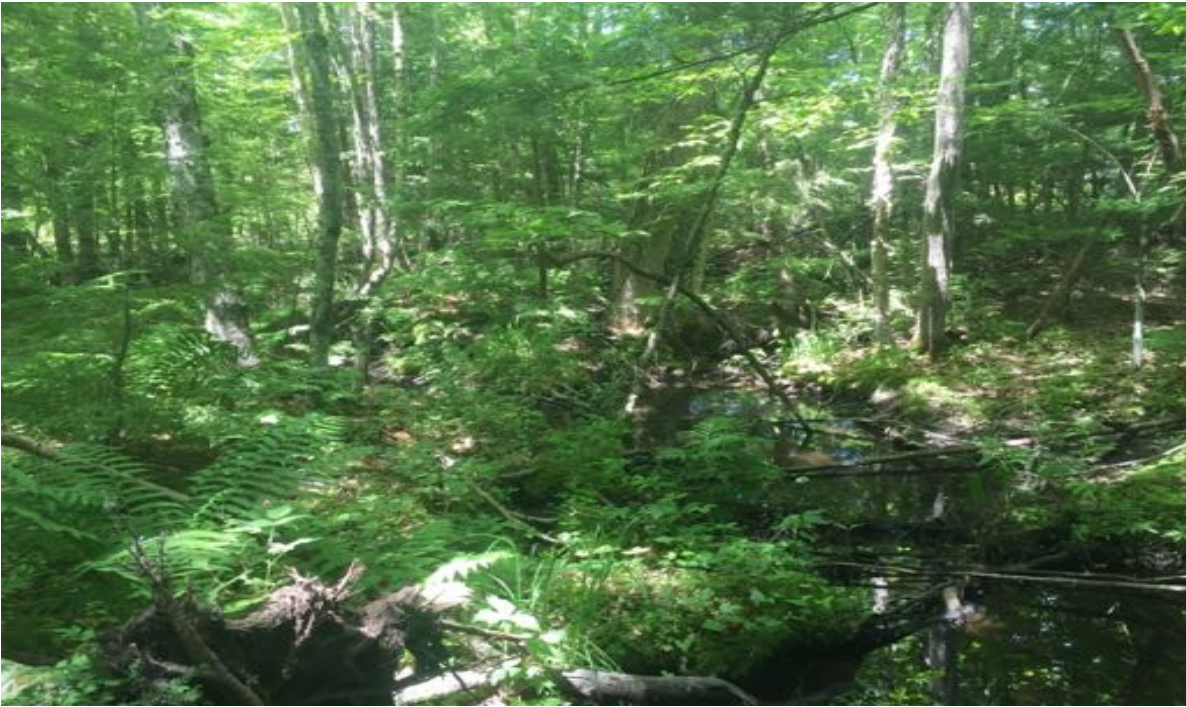
View of the stream in the wetland
